Removing Carbon From Baking Pans

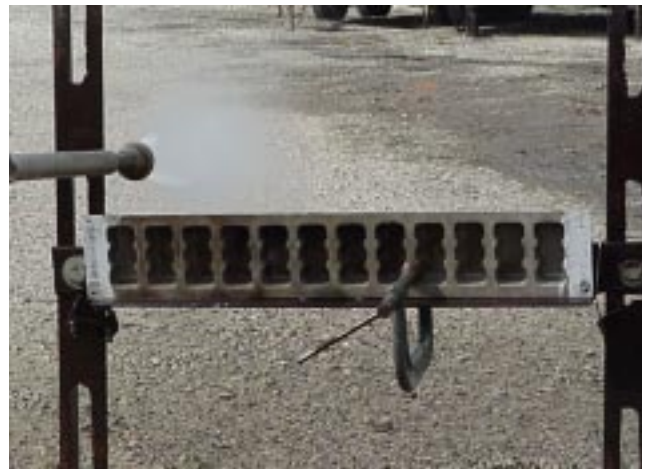
Pan being cleaned with NLB 8400A-2 rotating cleaning lance.

NLB helped the customer solve this problem by using an NLB 4030D pump, which provides 1.5 GPM (5.7 lpm) at 40,000 psi (2,800 bar). The water was applied with an NLB 8400A-2 rotating cleaning lance. This combination cleaned a typical pan in less than a minute.

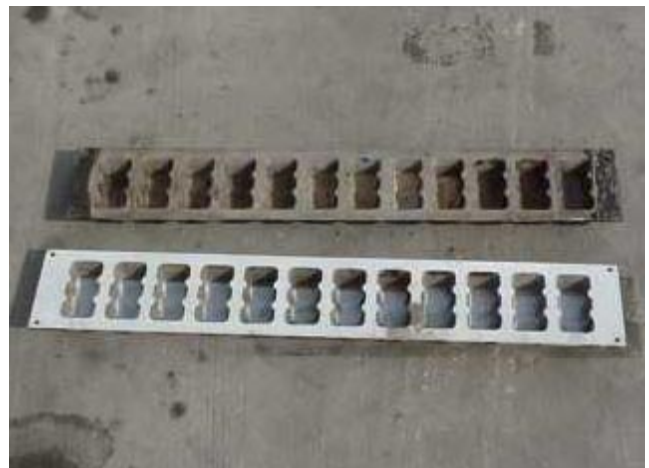
Before and after cleaning.

NLB was recently approached by a customer in the baking industry with a need to clean the baking pans used in production of their products. These pans accumulate carbon build-up from mold release agents oxidizing in the ovens. In this particular application, there was a 3/8 inch thickness of carbon build-up on the pans.
